Maryland Historical Trust Maryland Inventory of Historic Properties Form

Inventory No. HO-467

historic	Cooney-Smith Farm
other	George Richardson Farm, MacBeth Farm

street and number	12799 Clarksville Pike	___	not for publication
city, town	Clarksville	<u>X</u>	vicinity
county	Howard

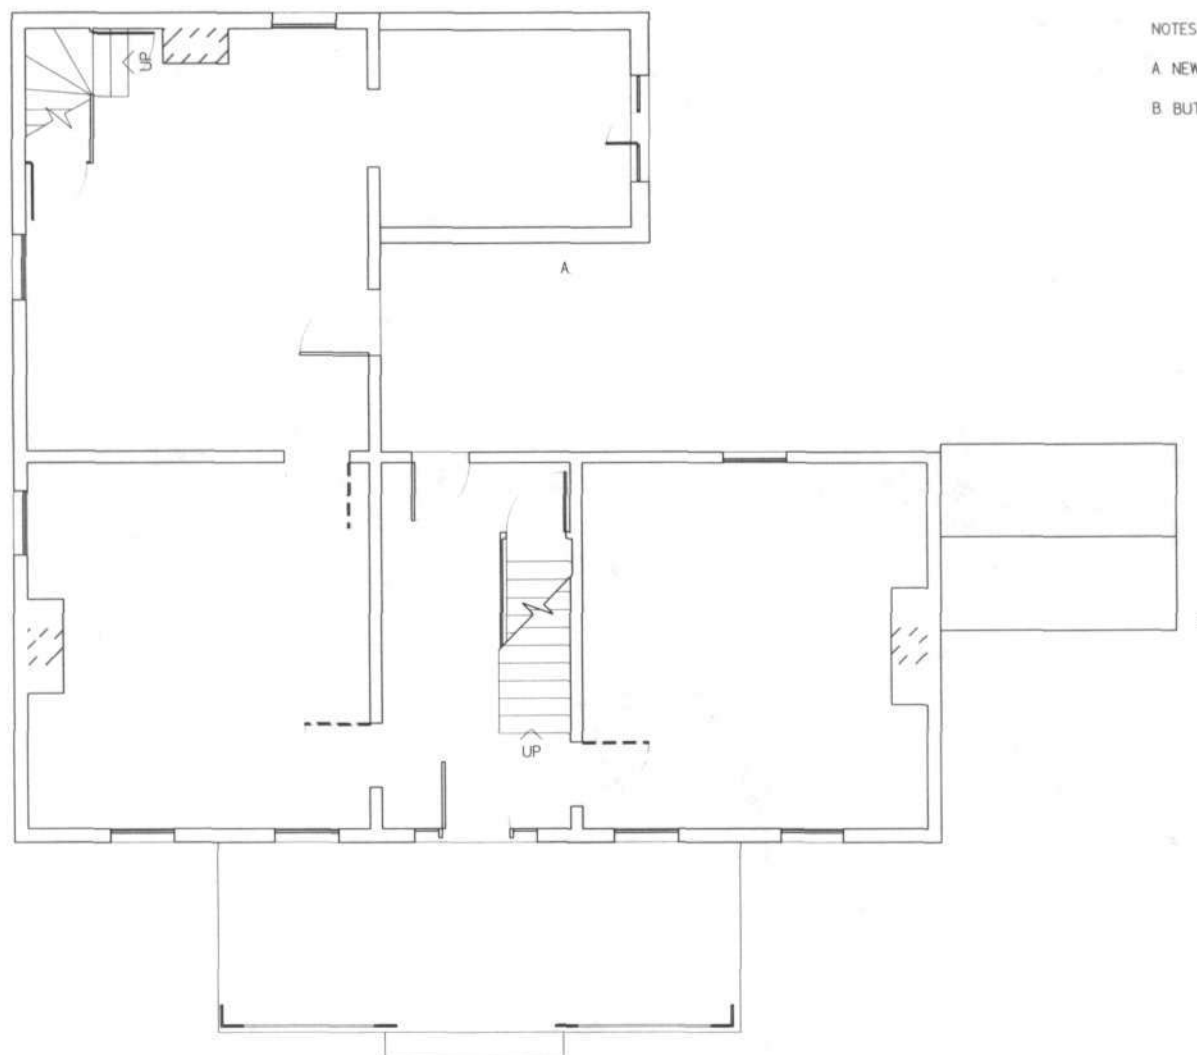
HOUSE FIRST FLOOR PLAN - MEASURED AND DRAWN BY KEN SHORT - APRIL 2006

A. NEW WALL NOT SHOWN

B. BUTTS CMU GARAGE (NOT SHOWN)

The first story has a center-passage, single-pile plan with one room in the ell. The passage has 3-inch wide pine flooring that runs east-west, baseboard with a quirked ogee, and symmetrical architrave with two beads on either side of an ovoid torus, a beaded

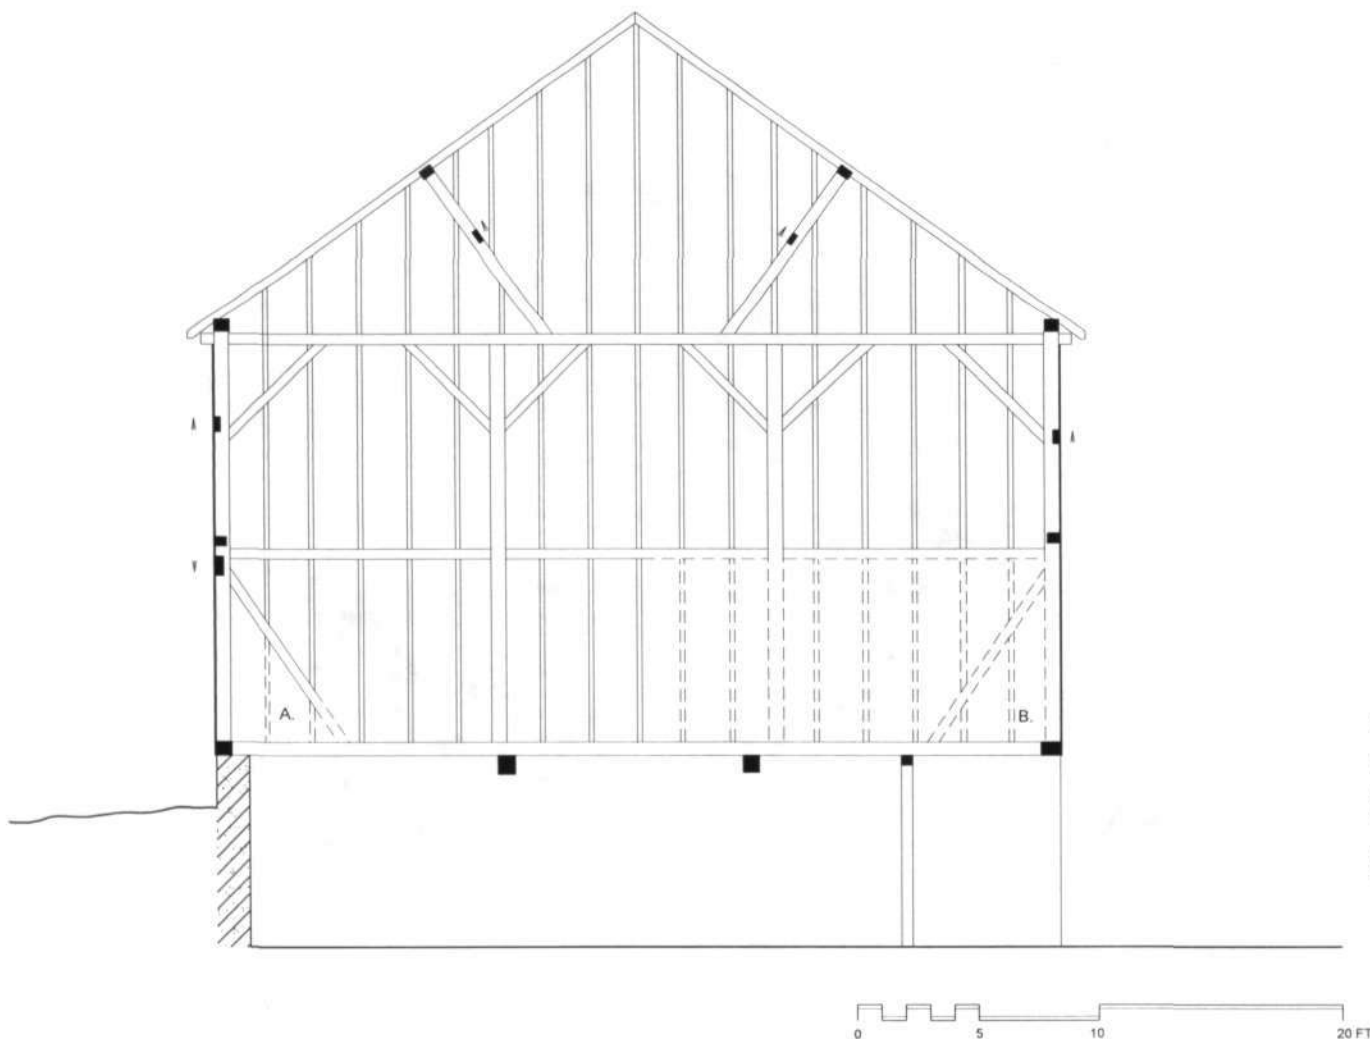
BARN EAST BENT FRAMING SECTION - MEASURED BY KEN SHORT AND TOM RINEHART - DRAWN BY KEN SHORT - MARCH 2006

A. FRAMING ROTTED/MISSING.

B. FRAMING COVERED BY INTERIOR
BOARD SHEATHING.

C. NEW SCABBED PIECES/REPAIRS
NOT SHOWN.

The upper story has a center-threshing floor with a hay mow to each side. The southern half of the eastern mow is enclosed with three rooms for storage, but there are no grain bins and no evidence that there ever were. There are vertical doors on butterfly hinges giving access to these rooms. The barn has a heavy timber, circular-sawn, mortised and tenoned and pegged frame. The center bents have one center post while the end bents each have two center posts, and there are both up and down braces and studs for horizontal siding. There are half-lap scarf joints with undersquinted ends, and four face pegs (one of which is offset because the stud is tenoned into here). The studs are tenoned at the top and bottom. The roof framing has purlin struts, and the rafters are mitered and butted at the ridge.

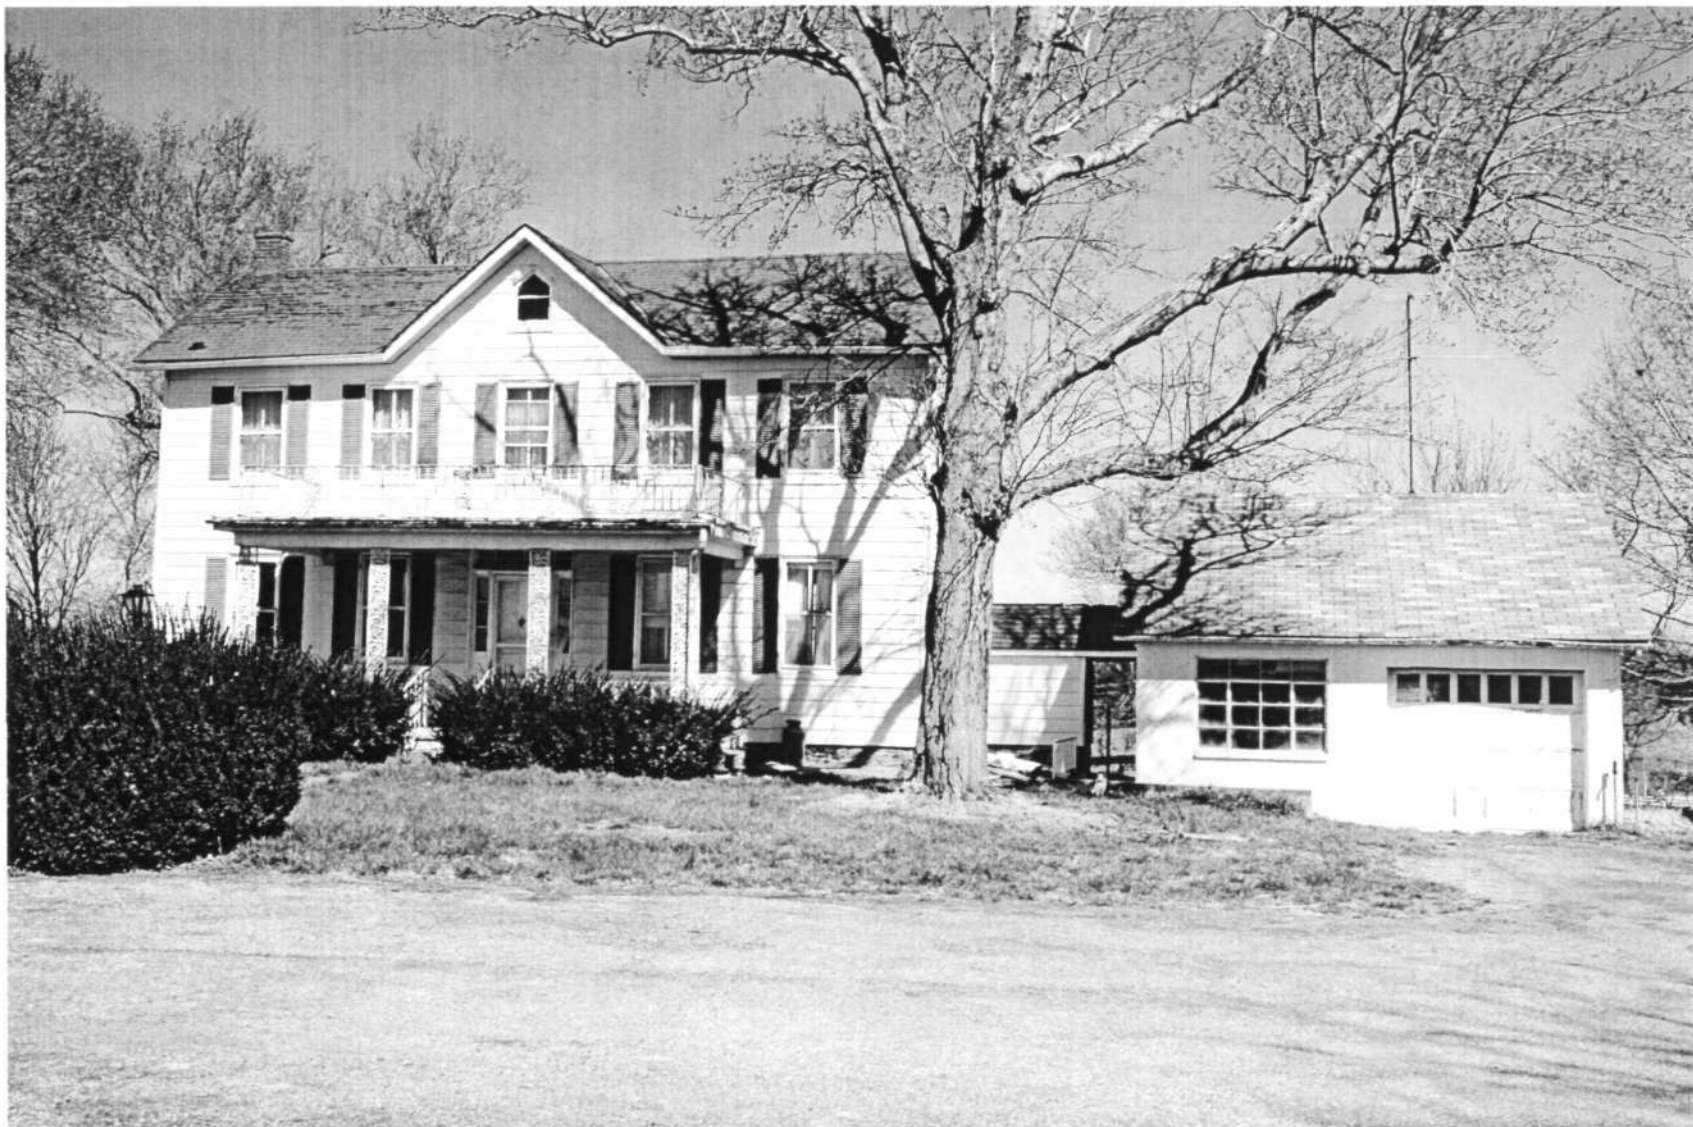
HO-0467 Cooney-Smith Farm 12799 Clarksville Pike, House-south elevation
Ken Short, March 2006 1/20

The house is a 2-1/2-story, five-bay by one-bay frame structure with a rubble stone foundation, aluminum siding covering German siding, and a gable roof with asphalt shingles and an east-west ridge. There is a two-story, one-bay by one-bay ell on the north elevation that matches the main block in materials and has a gable roof with a north-south ridge. The south elevation of the main block has a main entrance on the first story that has a four-panel door with sunken fields and ogee panel moulds. The sidelights have three lights over one panel. There is a four-light transom, with the end lights being smaller in order for the muntins to align with the doorposts. The doorposts and transom are chamfered and the doorframe has a beaded interior edge. There are two two-over-two double-hung sash on either side of the doorway, and they have beaded interior edge frames, fake blinds, and hardware for earlier blinds. There is a three-bay, one-story porch with a tongue and groove wood deck, cast iron foliate posts and balustrade, a board soffit, and a flat metal roof with an iron balustrade. The second story has five typical two-over-two sash, and there is aluminum on the soffit of the box cornice. There is a central gabled wall dormer with a two-light sash that has a triangular top. Each gable end has an interior brick chimney.

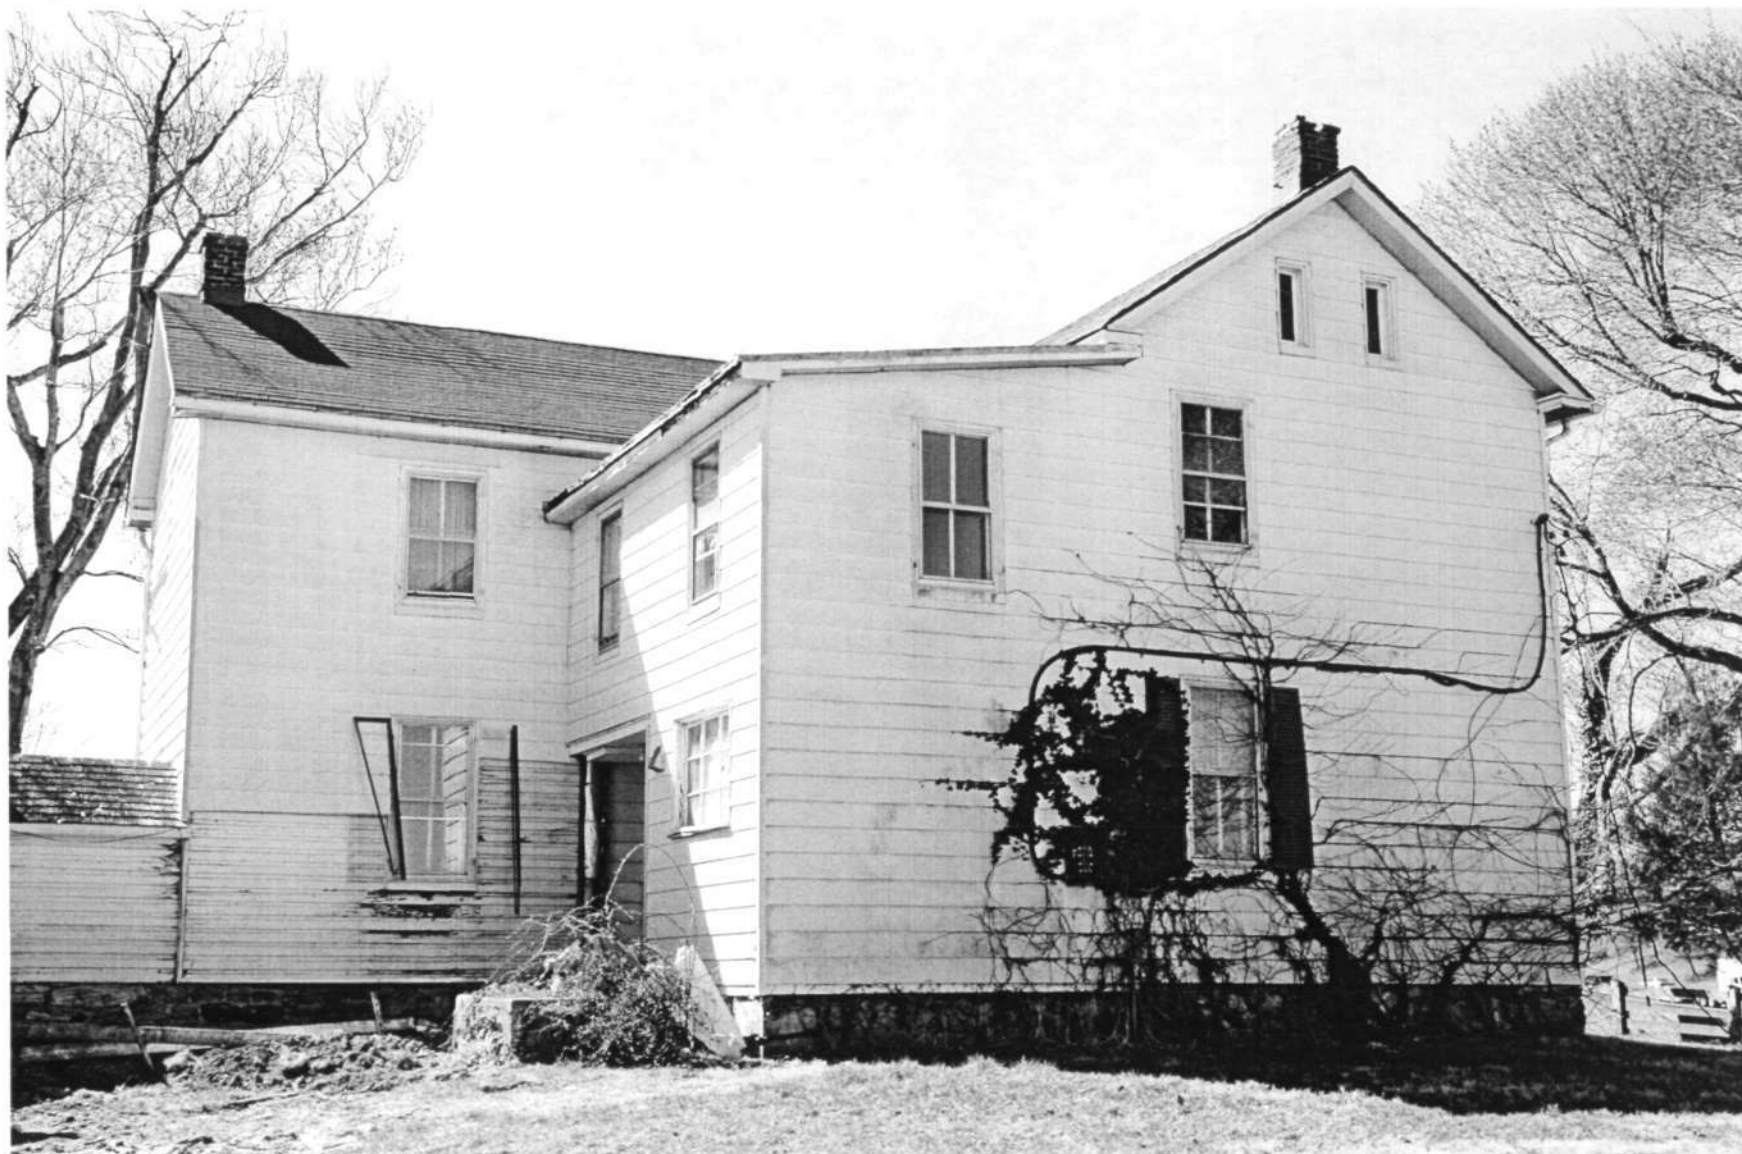
HO-0467 Cooney-Smith Farm 12799 Clarksville Pike, House-north elevation
Ken Short, March 2006 2/20

The north elevation of the main block has had some of the aluminum removed to reveal the German siding. Both the first and second story have a typical two-over-two sash. There is a low, one-story extension on the east, near the north corner. The rubble stone foundation is continuous with that of the main house, and there is German siding and a gable roof that has wood shingles and an east-west ridge. This roof projects to the east and connects to the garage. The east elevation of the main block has a vertical-board door hung on butterfly hinges in this extension, and the door leads to cellar steps. There are no openings on the first and second stories, or in the gable end.

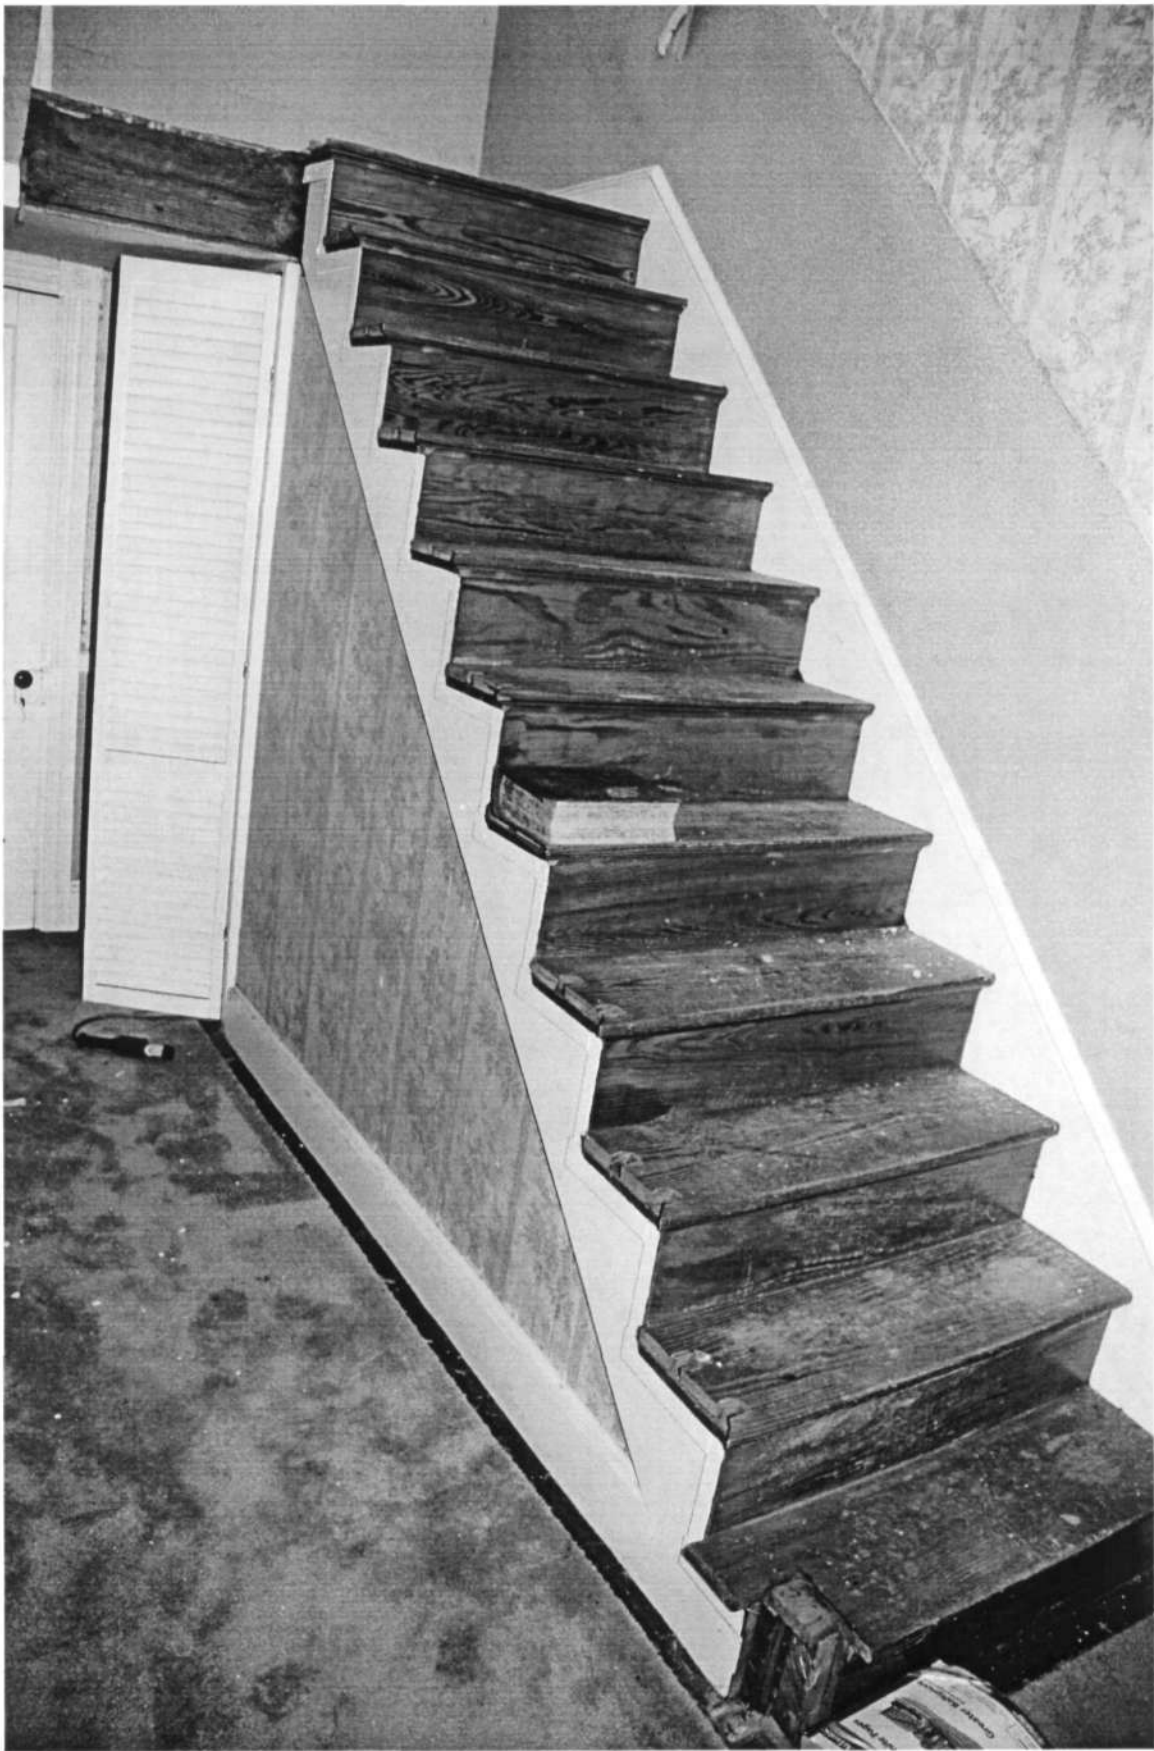
HO-0467 Cooney-Smith Farm 12799 Clarksville Pike, House-center passage, view northeast
Ken Short, March 2006 4/20

interior edge, and bull's-eye corner blocks. The interior doors have been removed. The front door has sunken fields with small ogee panel moulds. There are stamped iron plate butt hinges with three knuckles and pins. The cast iron rim lock is not labeled but has a little foliate decoration, and has a mineral knob. The sidelight panels match the door, and the rails and stiles of the sidelights and transom are all mortised and tenoned and pegged. The door also appears to have small pins. There is modern chair rail in this room. A dogleg stair ascends to the north on the east wall and has an open stringer and pine treads. The balusters and handrail have been removed and sold. The trim pieces are nailed with wire nails, while the structural pieces of the stairway are nailed with cut nails. Below the stringer are beaded-edge, vertical, tongue and grooved boards. The rear, or north, door has four panels that match the front door, and has a heavily painted cast iron rim lock with no clear markings and a mineral knob. The rear door is not pinned. The butt hinges have three knuckles and pins. There is a door beneath the stairway, leading to the cellar stairs, which has the same four panels and same lock and hinges as the rear door. It is mortised and tenoned and wedged, with no pins. The walls have a brown coat of plaster covered with wallpaper.

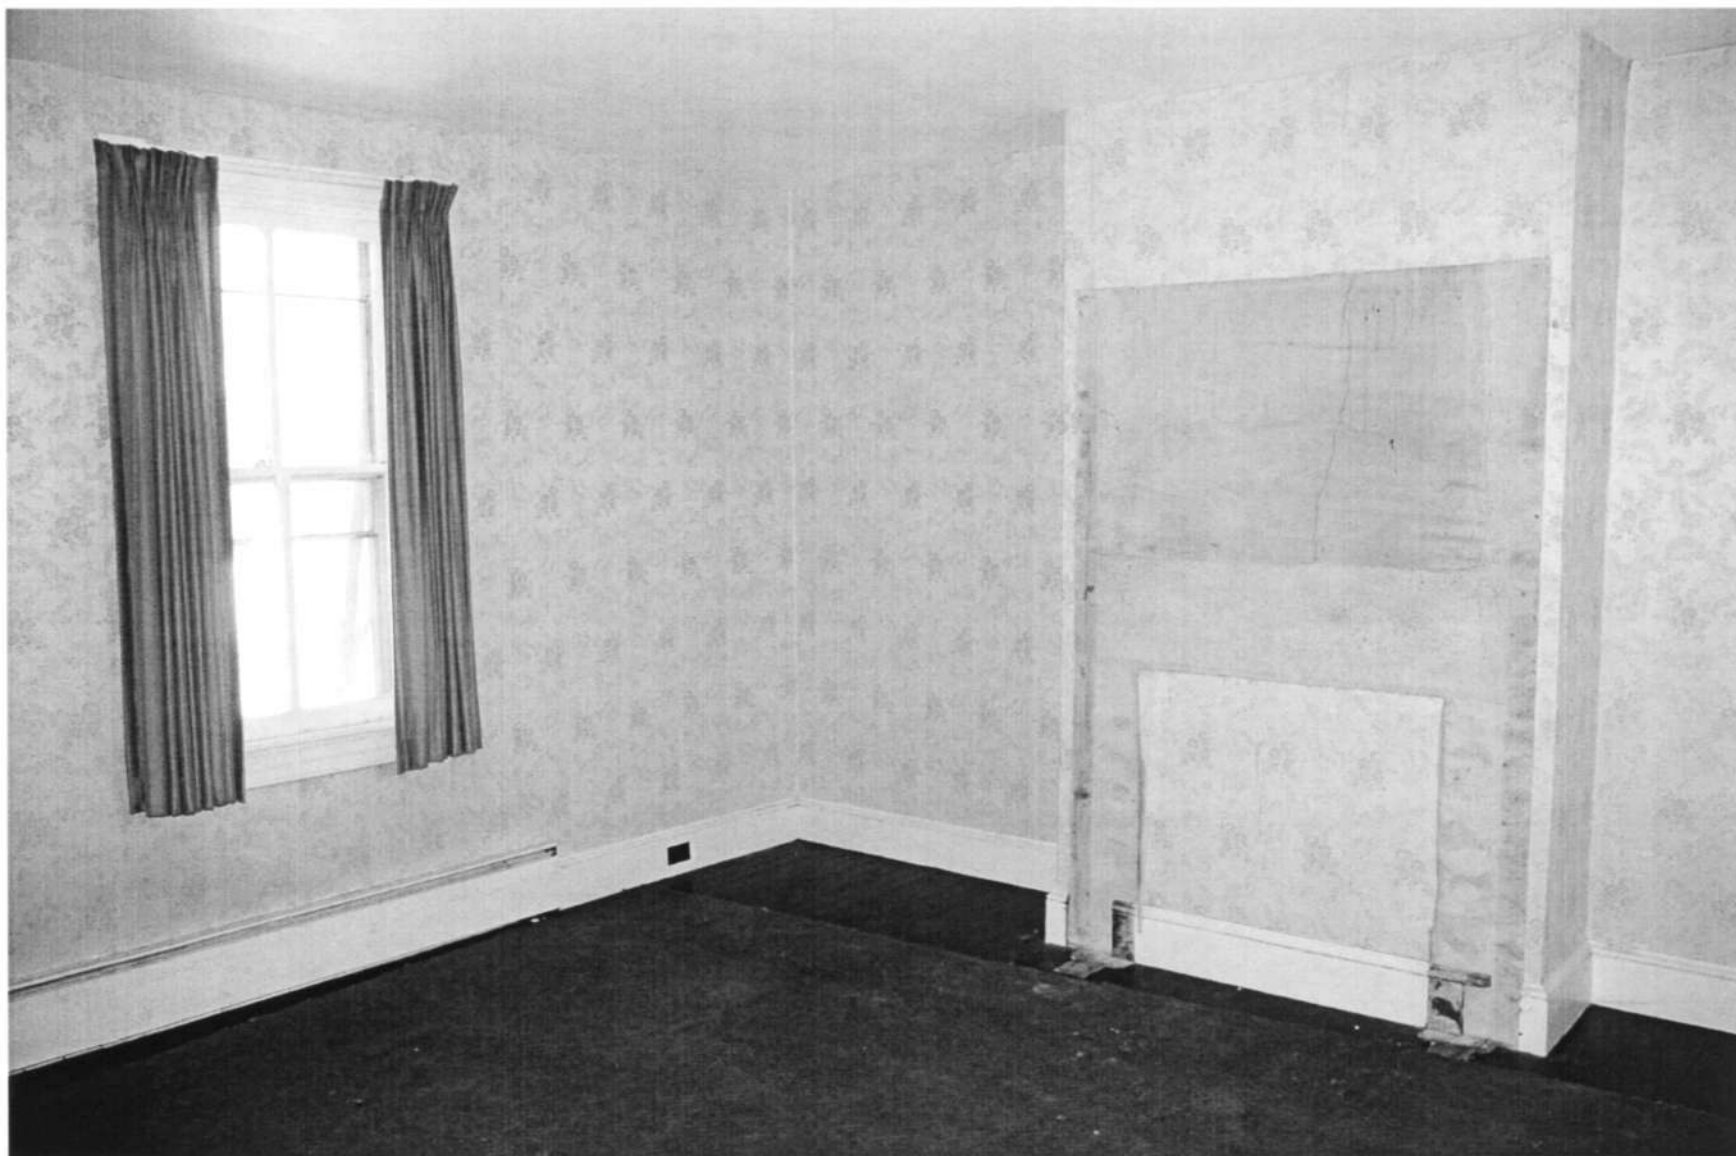
HO-0467 Cooney-Smith Farm 12799 Clarksville Pike, House-east room, view northeast
Ken Short, March 2006 5/20

The east room has the same flooring, baseboard and architrave as the passage, and this is typical for the house. The sash are hung on cords, have parting beads and check rails, and have wide muntins that are morticed, tenoned, and pinned. There are cast iron sash locks on the meeting rails. The baseboard is fastened with wire nails. There is wallpaper laid on the brown coat plaster surface. The mantel has been removed from the east wall and had an overmantel. It was all fastened with wire nails. There is a stovepipe hole at the bottom, and baseboard across the bottom indicating that there was never a fireplace here. The west room also has typical flooring, baseboard, architrave, and window sash. There is modern chair rail here. Beneath the wallpaper is newspaper dated 5 October 1987, Frederick, MD. The mantel was removed from the west wall, and again, was never a fireplace as there is a stovepipe hole and baseboard at the bottom. The wall is framed out and lathed and plastered on either side of the stove chimney to look like a fireplace. There is a doorway on the north elevation leading to the ell room, but the door is gone.

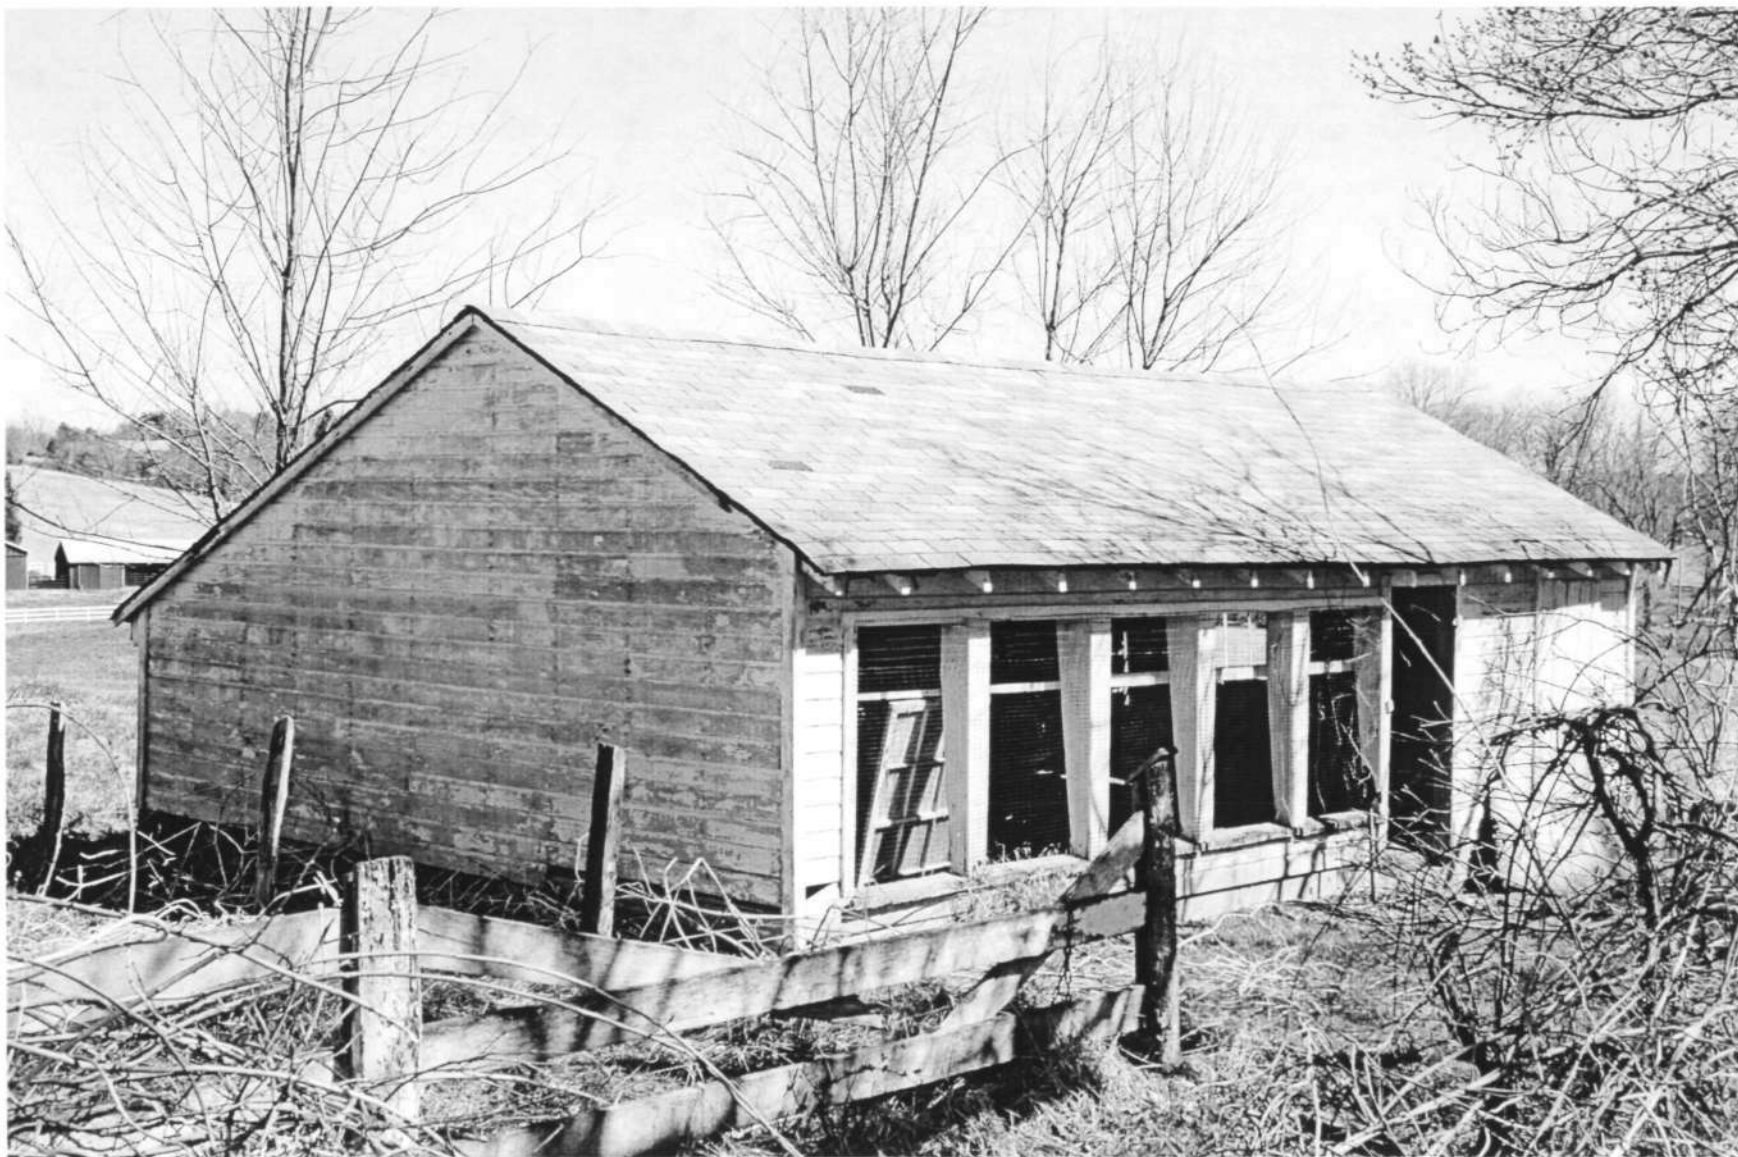
HO-0467 Cooney-Smith Farm 12799 Clarksville Pike, Large chicken house-west & south elevations
Ken Short, March 2006 6/20

The chicken house is located about 30 feet north of the smokehouse, and is a one-story, seven-bay by one-bay frame structure, with a CMU foundation, German siding, and a gable roof with asphalt and an east-west ridge. There are exposed rafters at the eaves. The south elevation has five large window openings with chicken wire and two V-groove vertical board doors on T-hinges to the east. There are no other openings in the building. The interior has a dirt floor and 2 by 4 construction in the walls and roof with solid board roof sheathing.

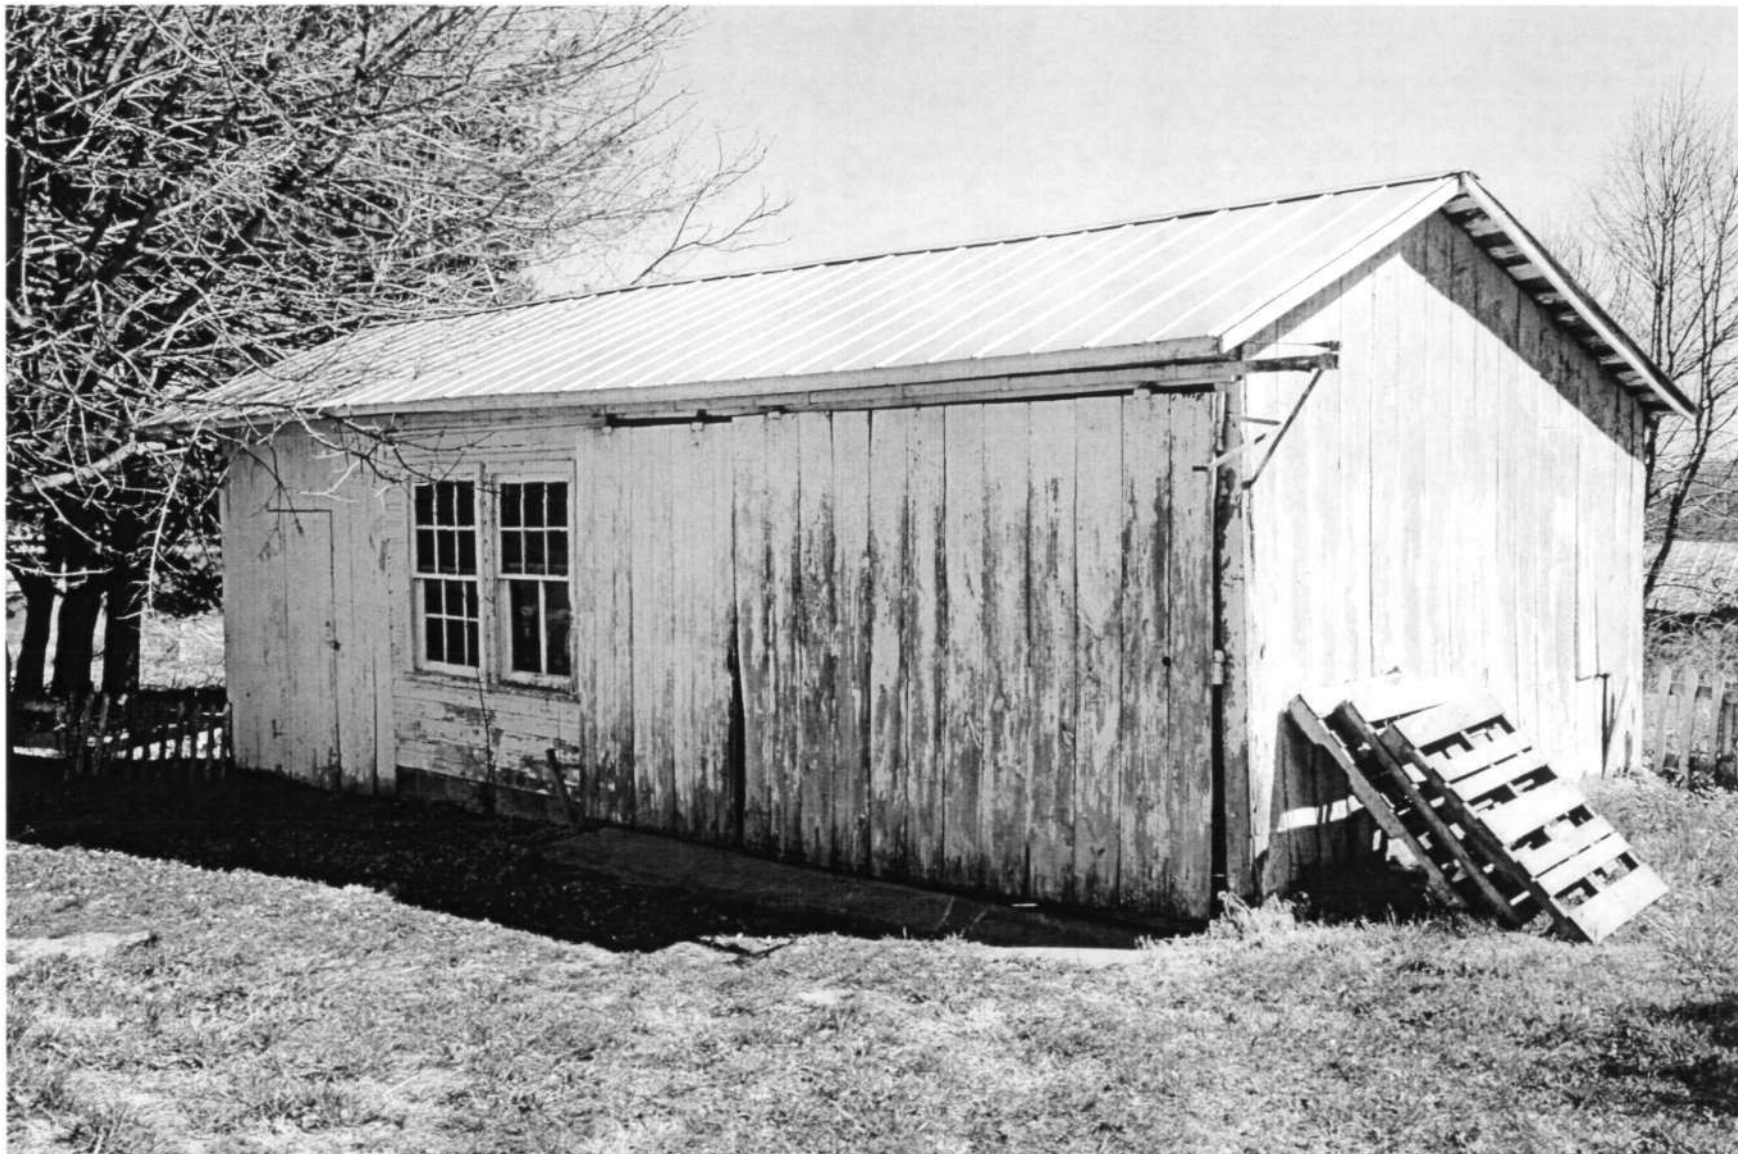
HO-0467 Cooney-Smith Farm 12799 Clarksville Pike, Carriage House-west & south elevations
Ken Short, March 2006 7/20

There is a carriage shed located about 18 feet east of the garage. It is a one-story, three-bay by one-bay frame structure with a partial CMU foundation. There is some German siding on the west elevation, in the center, and vertical board siding on the south, east, north, and north end of the west elevations. The gable roof has inverted V-seam metal and a north-south ridge. The rafters are exposed and the east half of the gable is longer. On the west elevation, the north bay has a vertical board door. The center bay has a six-over-six sash and a six-over-two sash that has pinned corners. The south bay has a set of beaded edge vertical board doors hung on rollers. There are no openings on the north, south, and east elevations. The carriage house is constructed of circular sawn 4 by 4 posts with 2 by 4 down braces and horizontal studs, all of which are wire nailed. There are 2 by 4 circular sawn

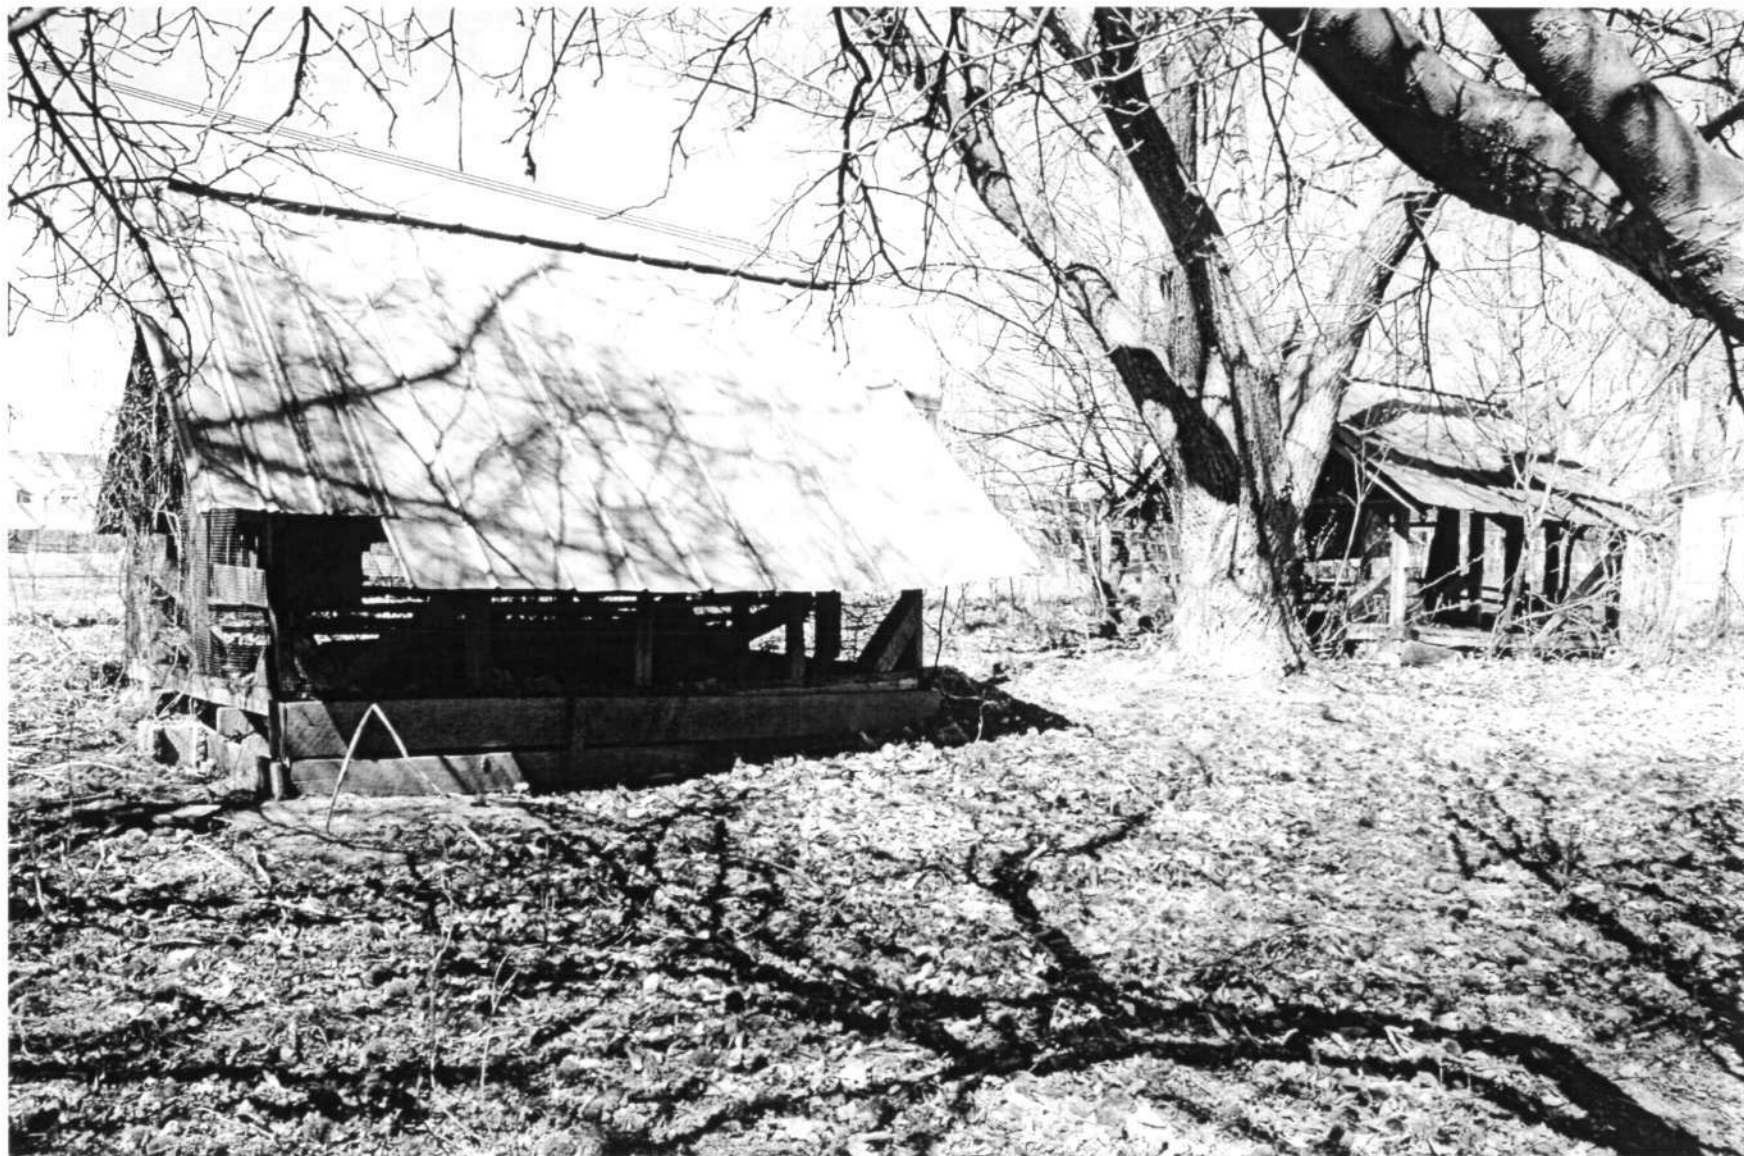
HO-0467 Cooney-Smith Farm 12799 Clarksville Pike, Chicken houses in orchard-view northwest
Ken Short, March 2006 9/20

To the east of the driveway and house is a chicken yard that is fenced on the east and west sides and has two rows of fruit trees running east and west. There are five small sheds set within the chicken yard in a general line running north to south. The shed building near the north end of the yard is set on the ground and has German siding and exposed rafters. It is one story, and one bay square. The shed roof slopes down to the west and has asphalt shingles. The building is of 2 by 4 construction with vertical boards over diagonal board sheathing. The east elevation has a beaded edge and center vertical door hung on rollers. About 14 feet south of this shed is a small chicken house that is set on the ground. It is one story and three bays by one bay. It has German siding and a shed roof with asphalt shingles that slopes down to the west. There is a wood box cornice. The east elevation has three 12-light fixed wood sashes. The north elevation has a vertical board door on T-hinges set to the east, and there are no openings on the south and west elevations. This building is also of 2 by 4 construction. To the south are three 2 by 4 frame chicken houses with chicken wire on all four sides. The two northern ones have inverted V seam metal on their gable roofs, and the south one has asphalt roll roofing. They are otherwise completely open.

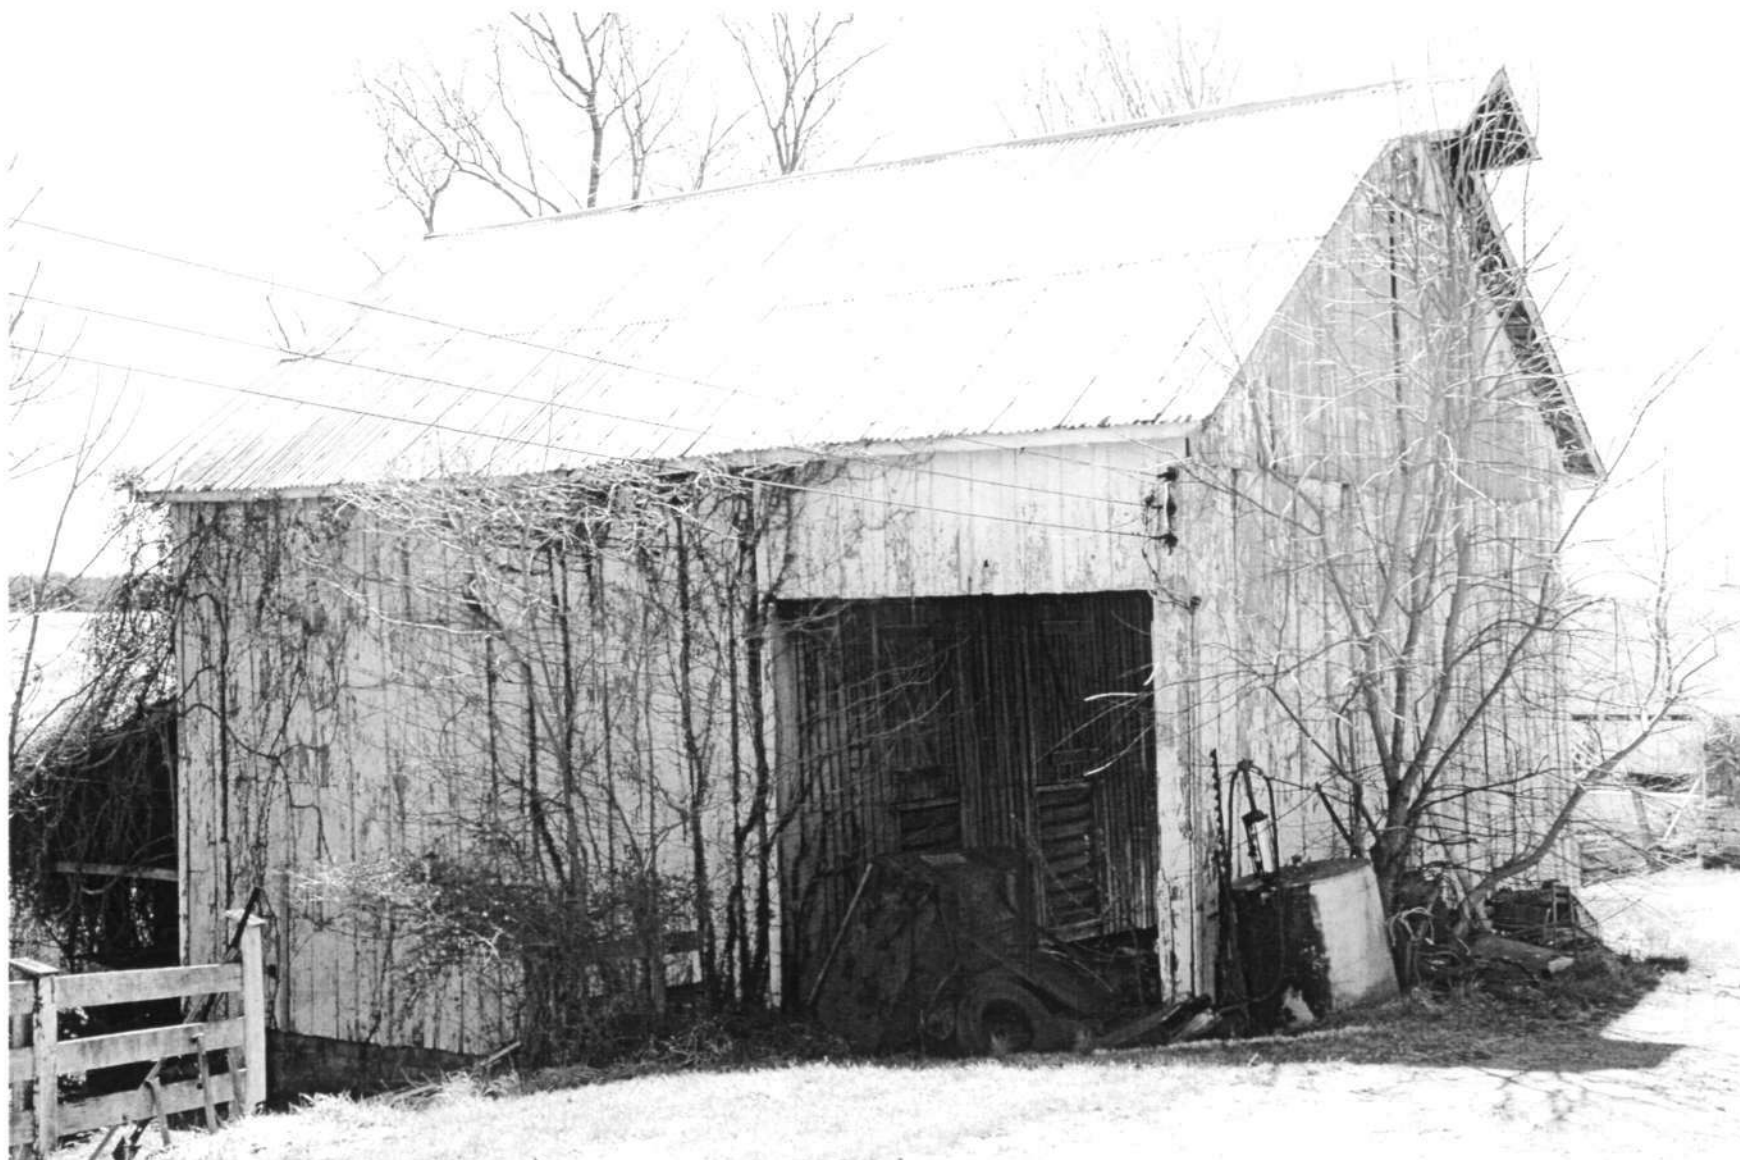
HO-0467 Cooney-Smith Farm 12799 Clarksville Pike, Wagon shed & corn crib-north & west elevations
Ken Short, March 2006 11/20

The wagon shed and corncrib are about 150 feet south-southeast of the house and are set on rubble stone piers. It is a frame structure with board and baton siding and a gable roof with corrugated metal, an east-west ridge and exposed rafters. It is a 1-1/2 story three-bay by one-bay structure. On the south elevation, the west bay has a wide, tall opening and there is no evidence that there were ever doors here. The center bay has a pair of vertical doors on T hinges, and the east bay has a wide but shorter opening than the west bay, and also has no evidence of doors. On the west elevation, there is a pair of board-and-batten doors on the gable end, and the roof overhands here and contains a chain to hang a pulley. The north elevation has a large opening in the west bay only. The east elevation has no openings, and there is an open shed added to this side. The building is constructed with a circular-sawn heavy timber frame that is mortised and tenoned and wire nailed at the foot. It is possible that the sill has been replaced, since the girts are pegged. The west door on the south elevation leads to the corncrib, while the east door leads to a winder stair that ascends to the east to the upper story. The building is of wire nail construction. The upper story is wide open and has 2 by 5 circular-sawn rafters that are mitered at the ridge, and several pairs of 3/4-round rafters that are also mitered. The plates sit on top of the posts, while the girts are dropped, and there are iron tie rods bolted to the top of a middle post on the north and south and pass through the floors at an angle. The top of the plates is 3 feet 3 inches above the floor. The rafters support the wood lath.
